Channel Change on the Santa Cruz River, Pima County, Arizona, 1936–86

By JOHN T.C. PARKER

U.S. GEOLOGICAL SURVEY
Open-File Report 93—41

Prepared in cooperation with the
PIMA COUNTY DEPARTMENT OF TRANSPORTATION
AND FLOOD CONTROL DISTRICT

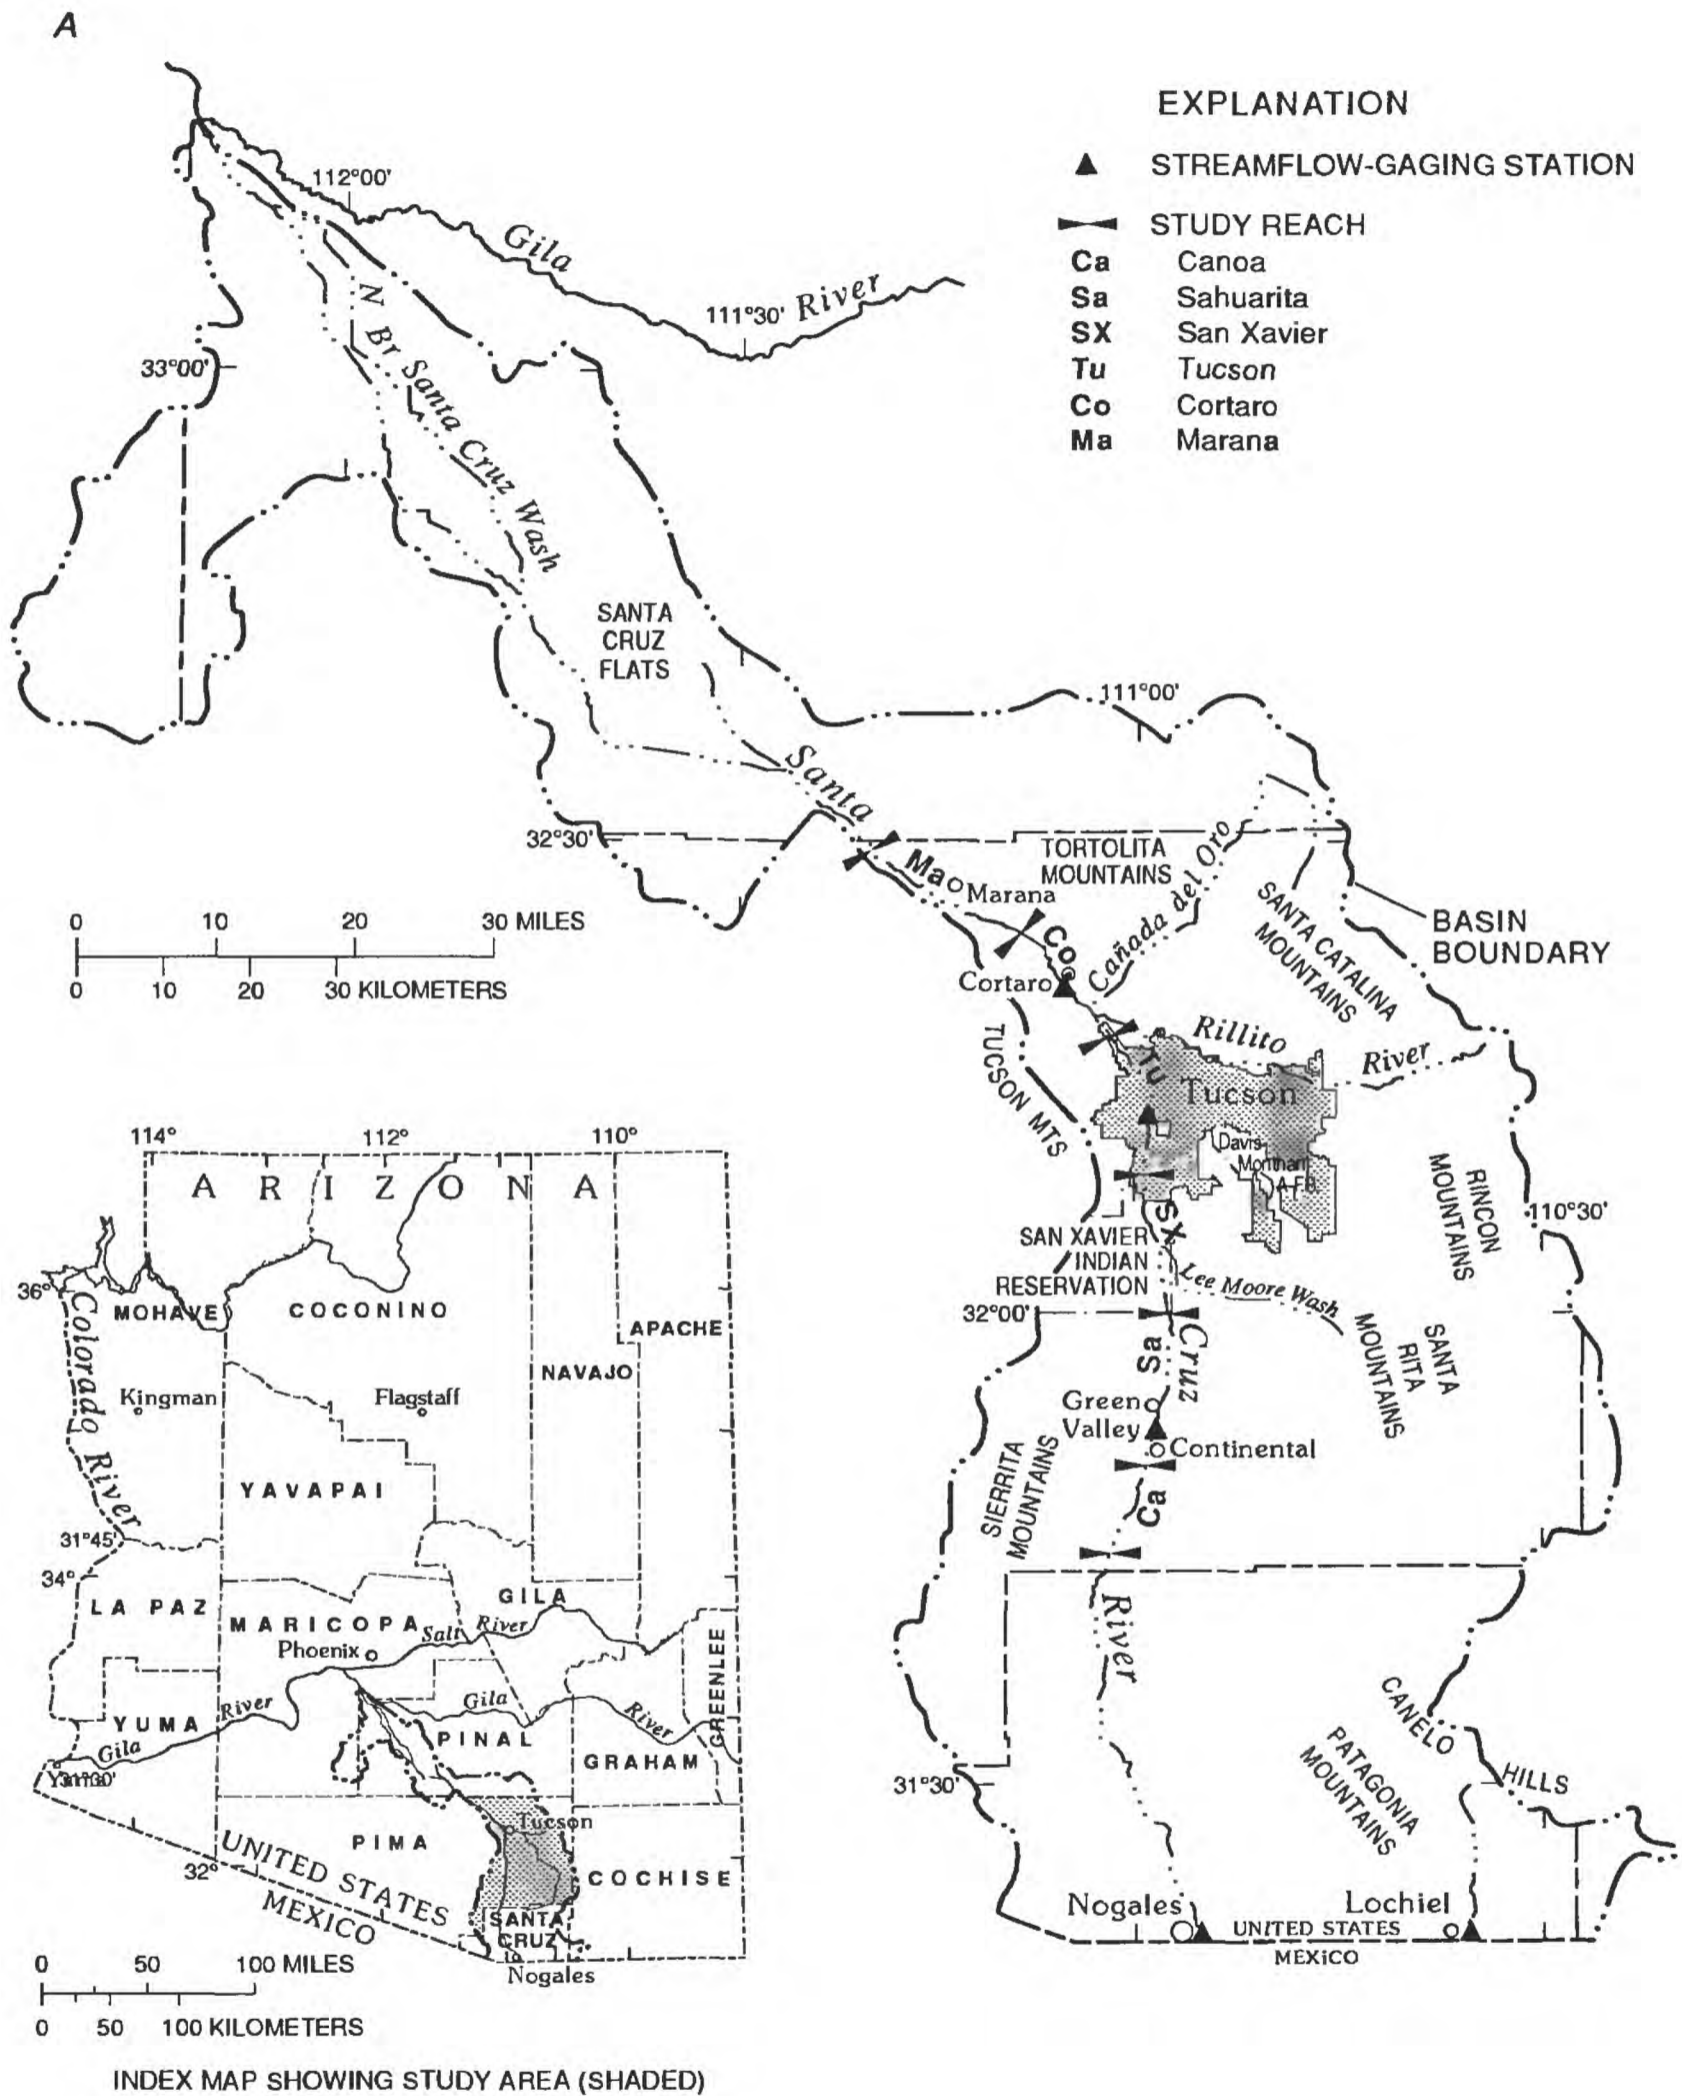
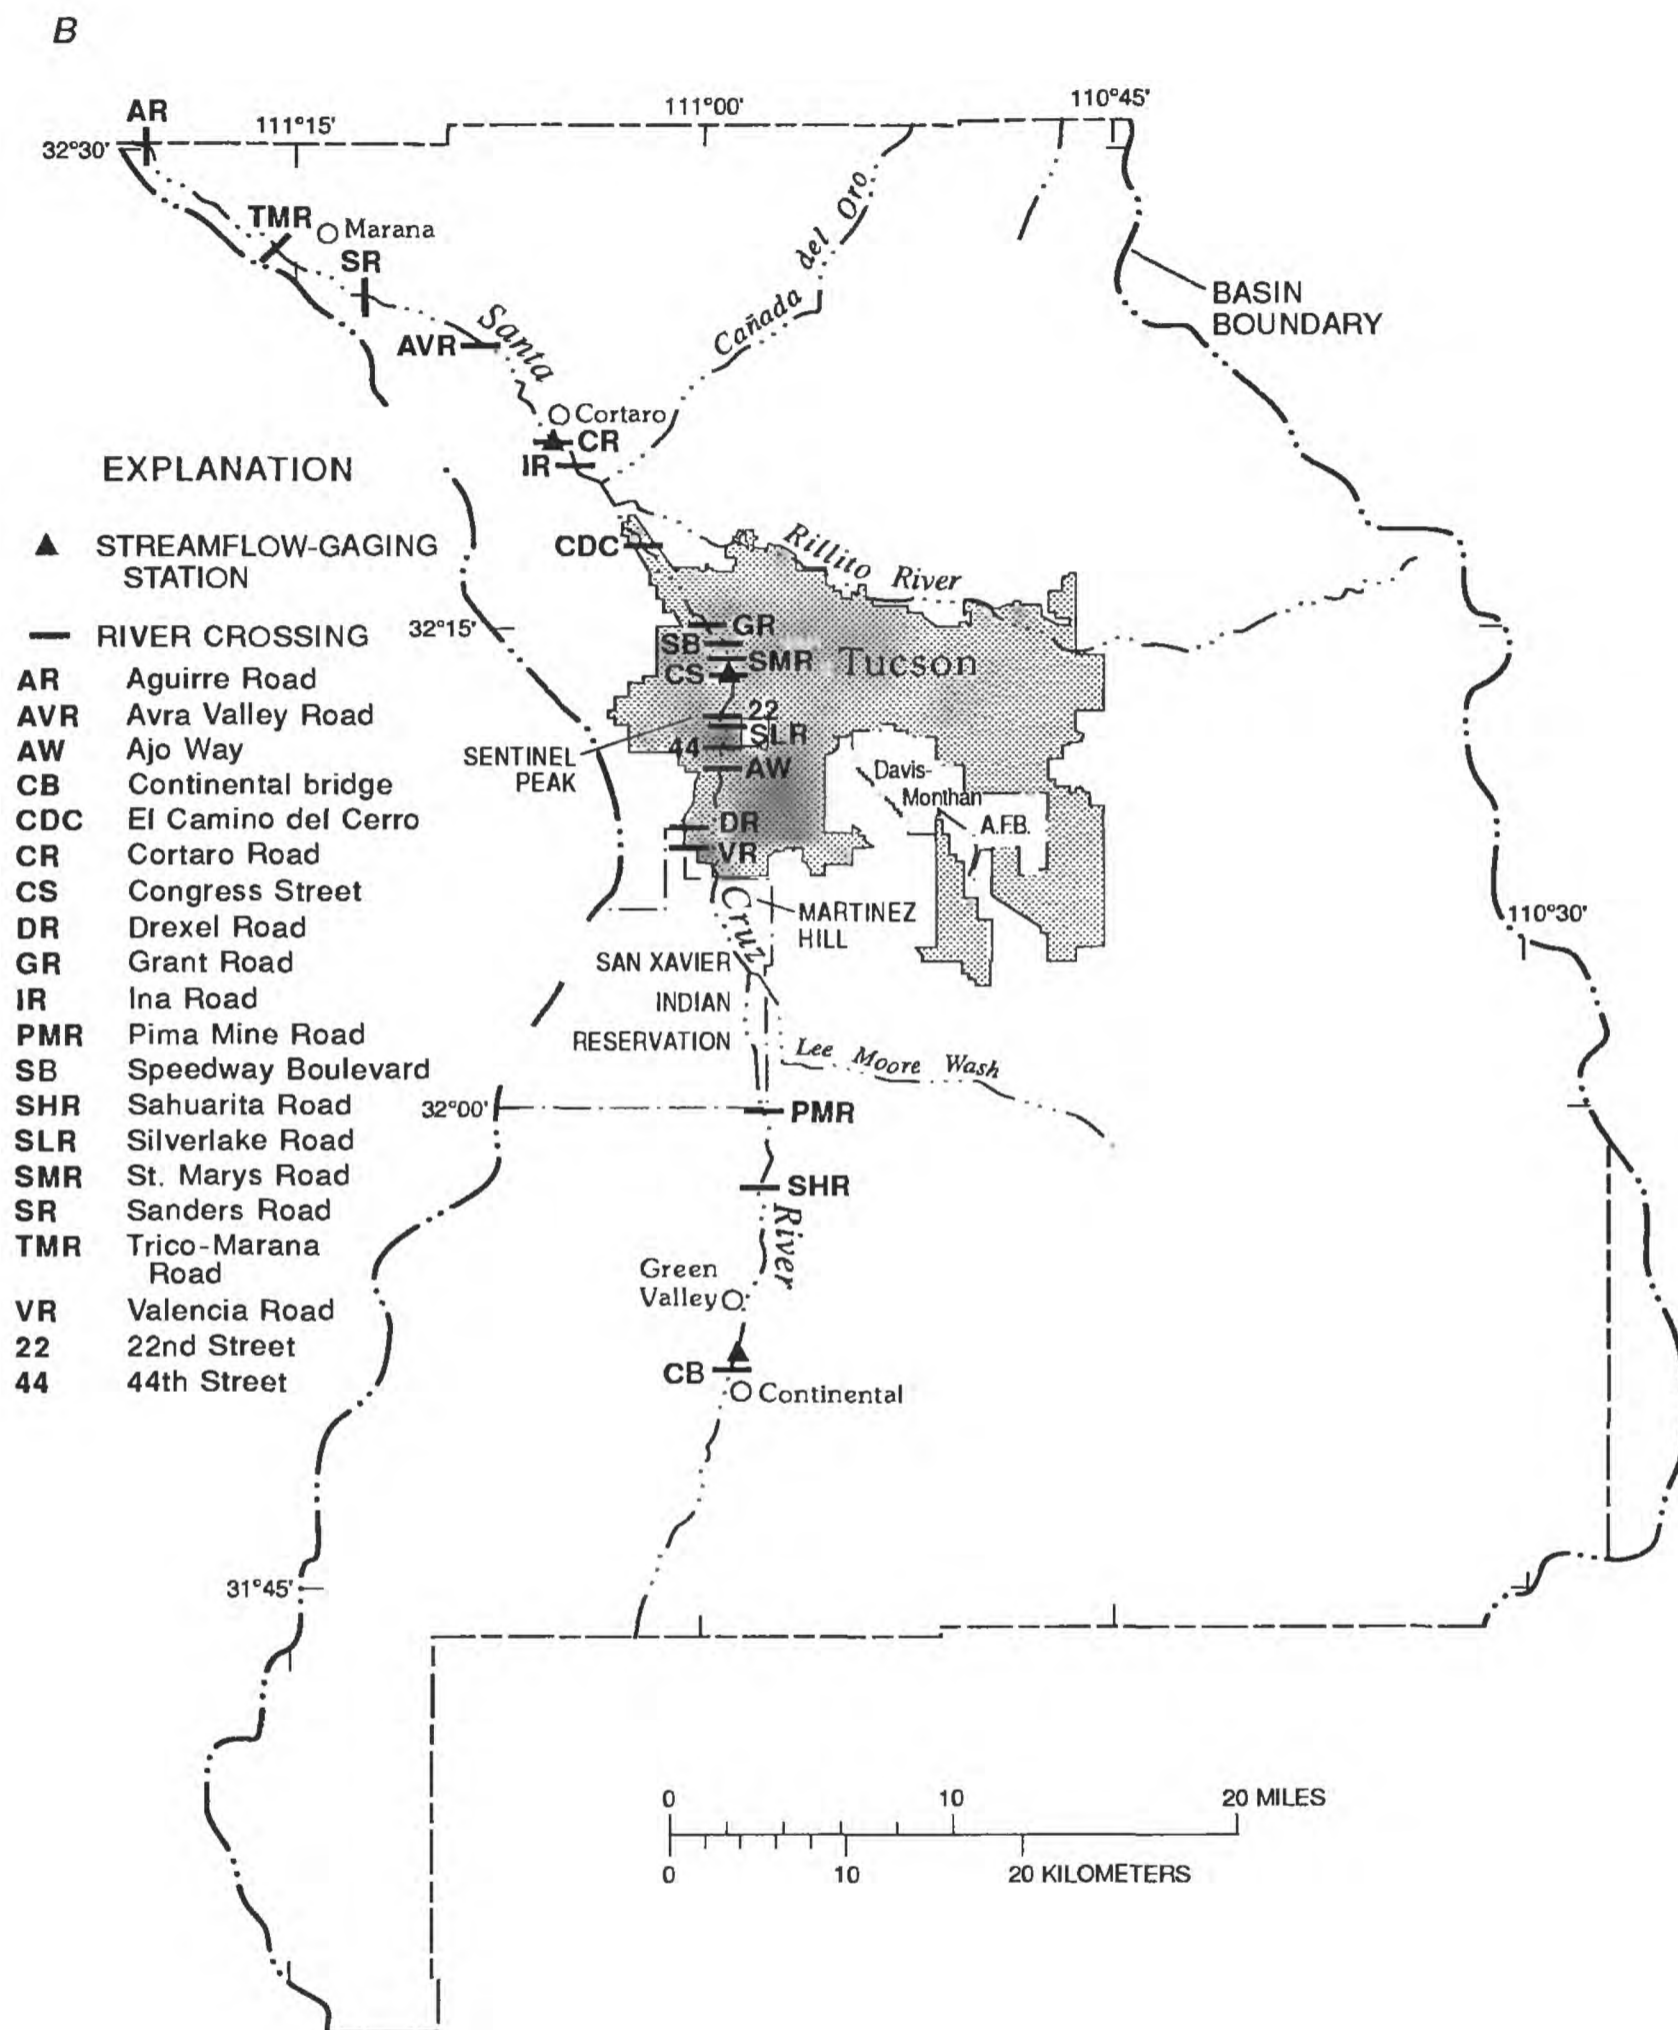
Figure 1. Santa Cruz basin, Arizona.

The Santa Cruz River, which at its confluence with the Gila River drains about 8,581 mi² in southeastern Arizona and northern Sonora, Mexico, is typical of large, ephemeral rivers in the western United States (fig. 1).

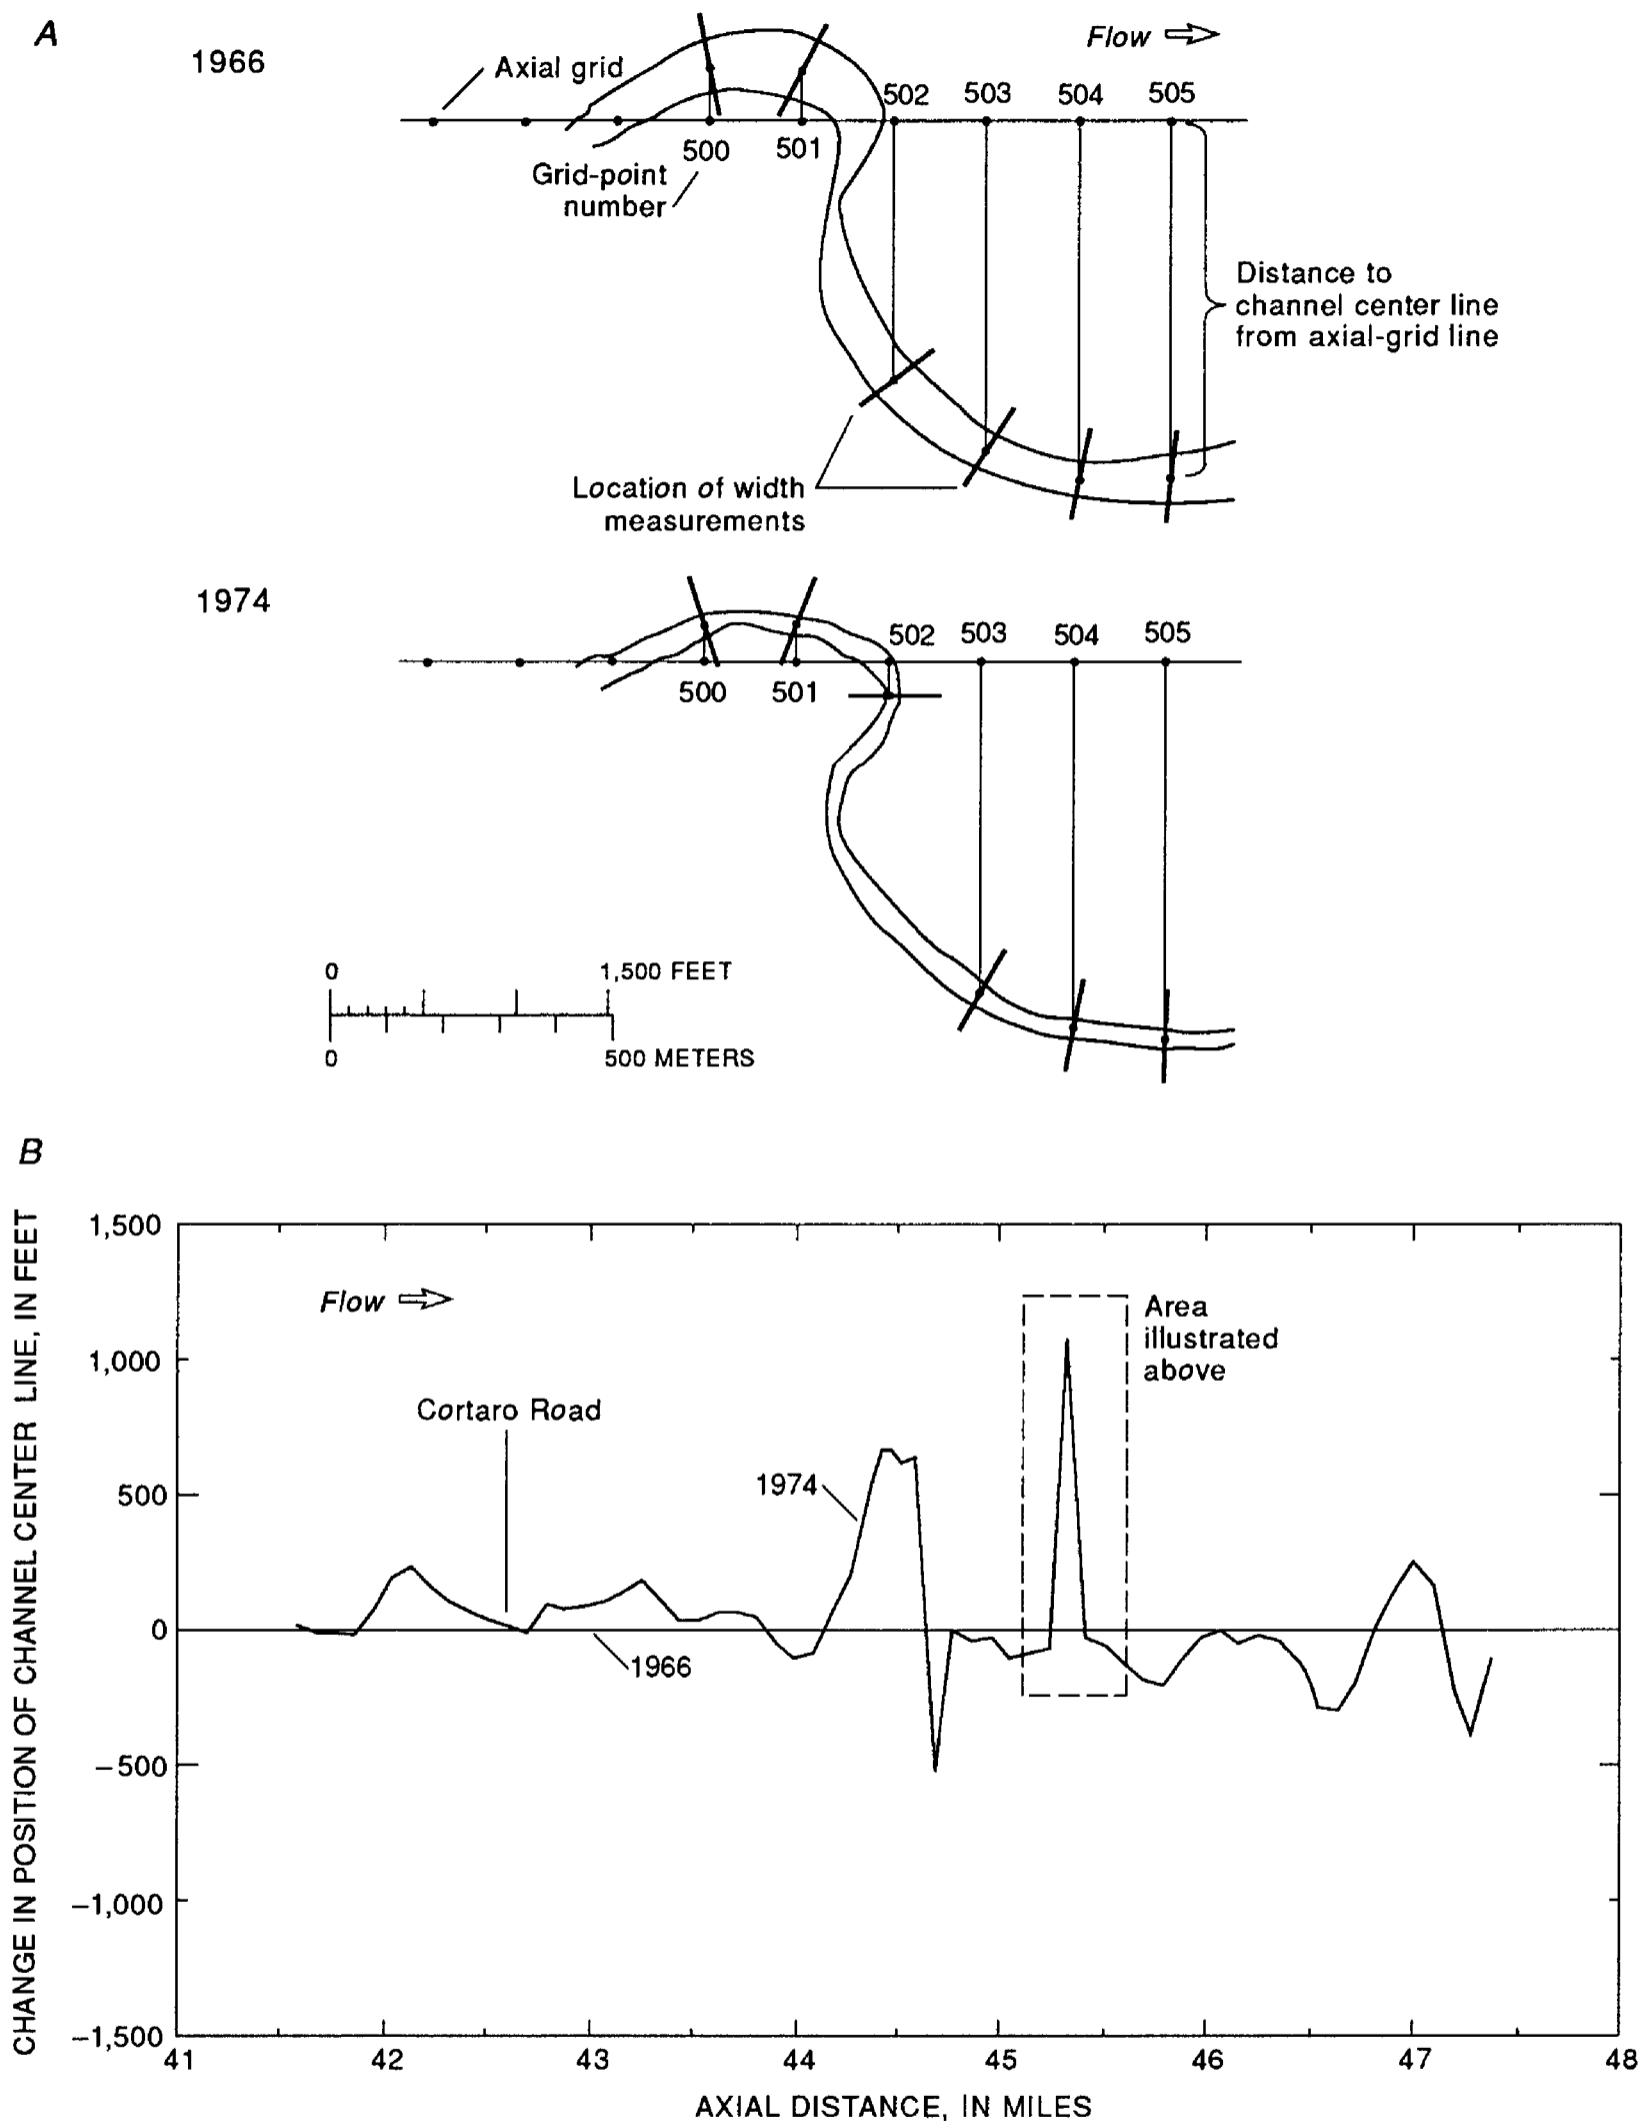
Figure 2. Method of relating channel change to axial reference system. *A*, Measurement of changes in width and channel position from 1966 and 1974. Note large shift in position relative to grid point 502 caused by rotation of meander axis. *B*, Change in position of channel center line with time. Positive values indicate shift in position toward left side of channel; negative values indicate shift toward right side.

new location of each channel center point relative to the channel axis (fig. 2B). Although plots such as figure 2B indicate lateral channel stability, the magnitude of shift in channel position is not a measure of bank retreat or meander migration, which is a vector quantity. Large shifts in position of the channel center line but minor amounts of channel movement can be caused by a change in channel orientation such as shown at grid point 502 in figure 2A and in the boxed area of figure 2B.

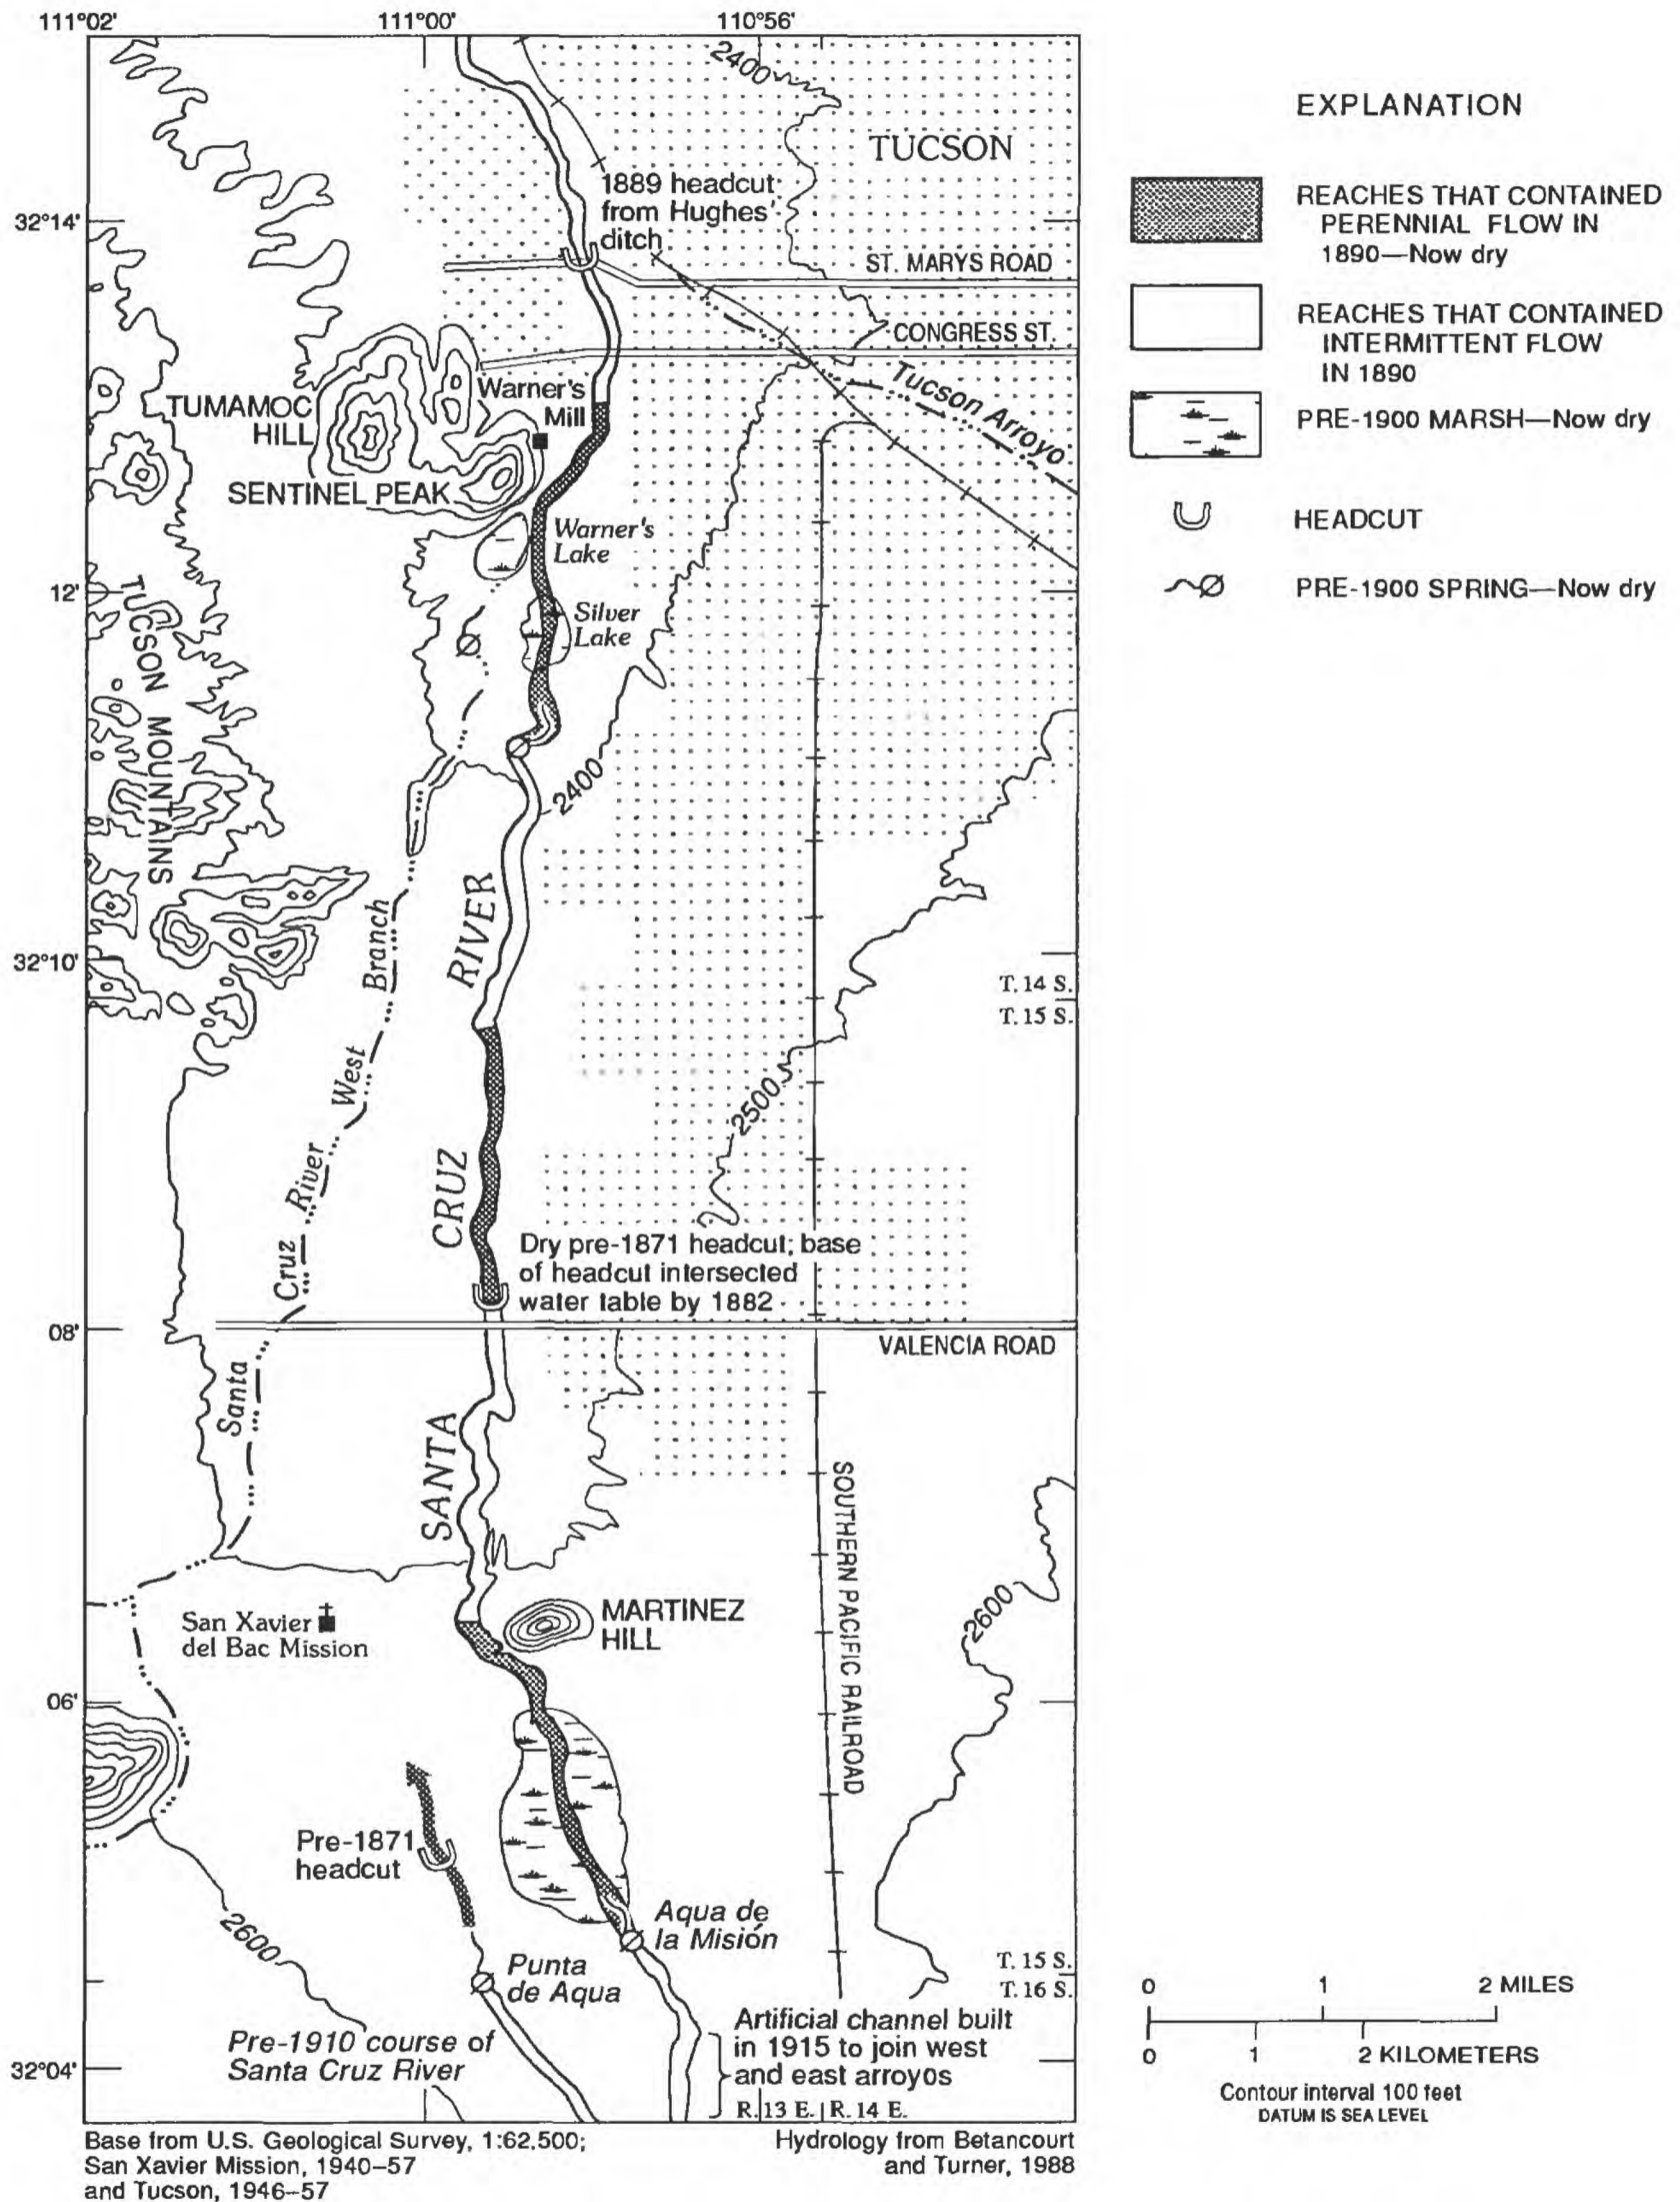
Figure 3. Santa Cruz River in 1988, perennial and intermittent reaches in 1890, and location of headcuts in relation to marshes in the late 19th century.

Headcuts signaling the onset of arroyo formation were first described in 1871 in the San Xavier area (fig. 3; Betancourt and Turner, 1988). In the late 1880's, extensive headcutting began through Tucson as a result of poorly engineered waterworks and high flows, particularly a series of summer floods in 1890. By 1910, the arroyo extended from Martinez Hill to Tucson. Winter floods in 1914-15 caused major channel widening and destroyed the bridge at Congress Street in Tucson. These floods also extended the headcutting through

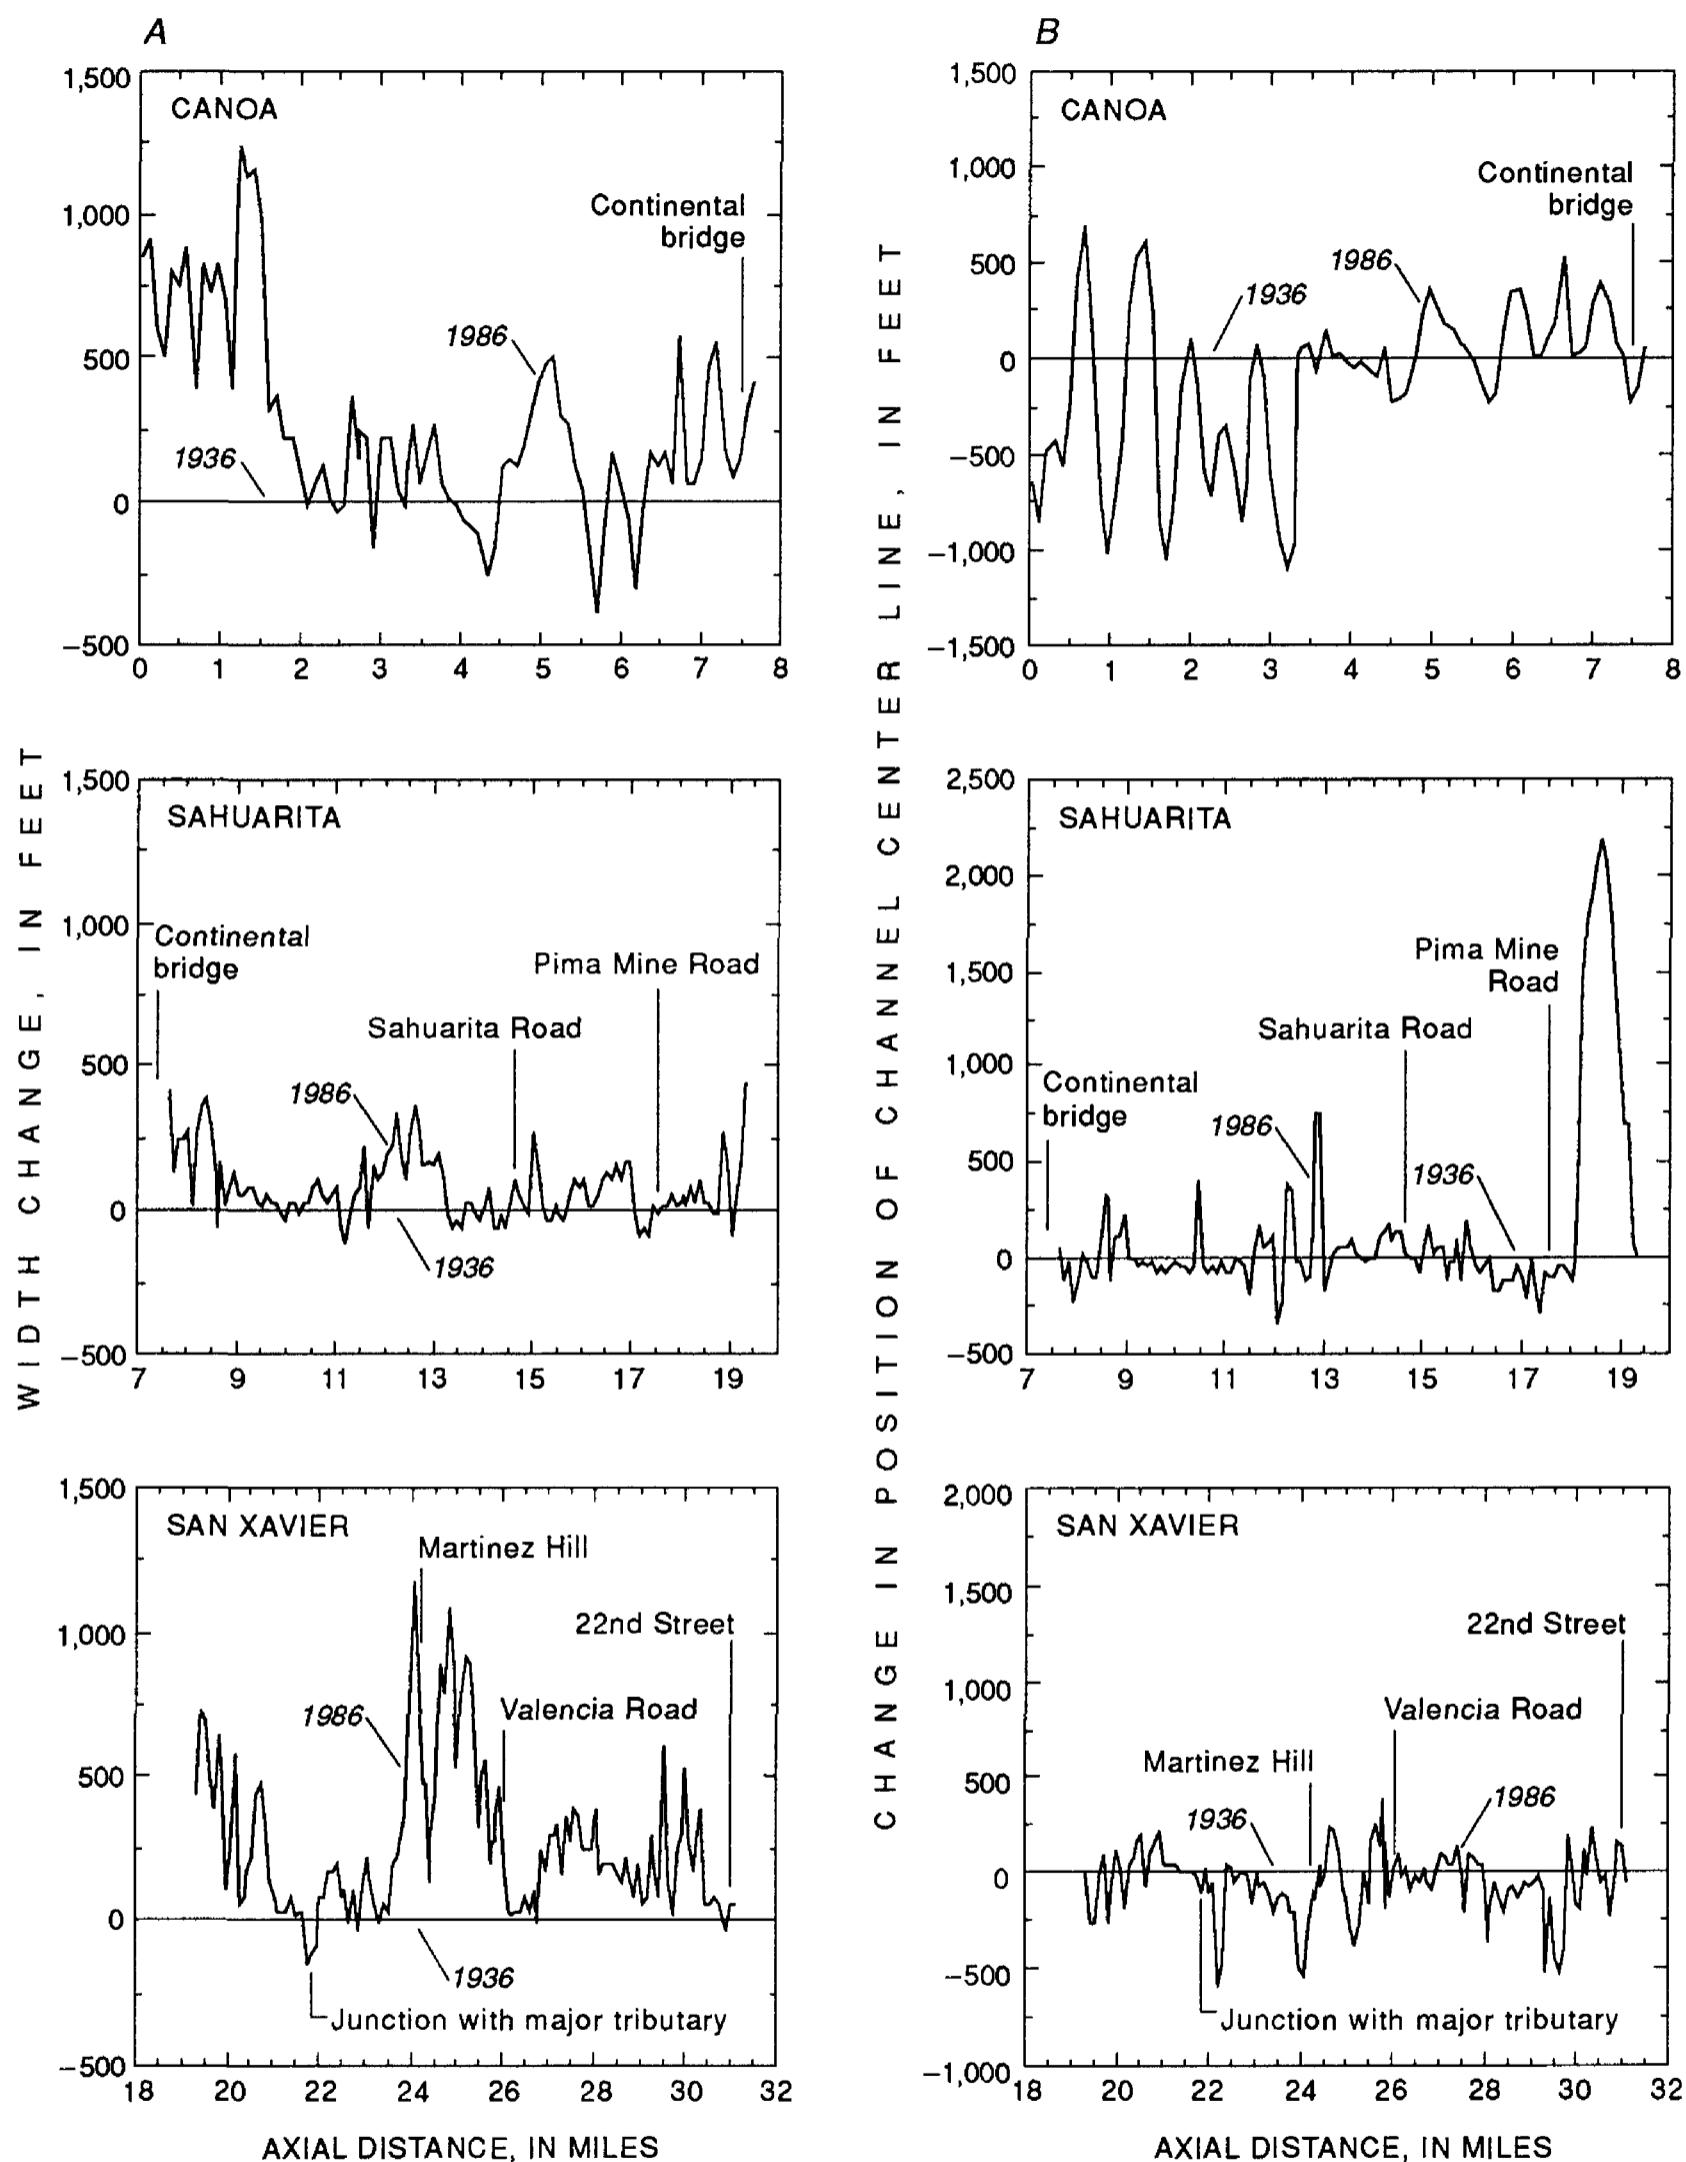
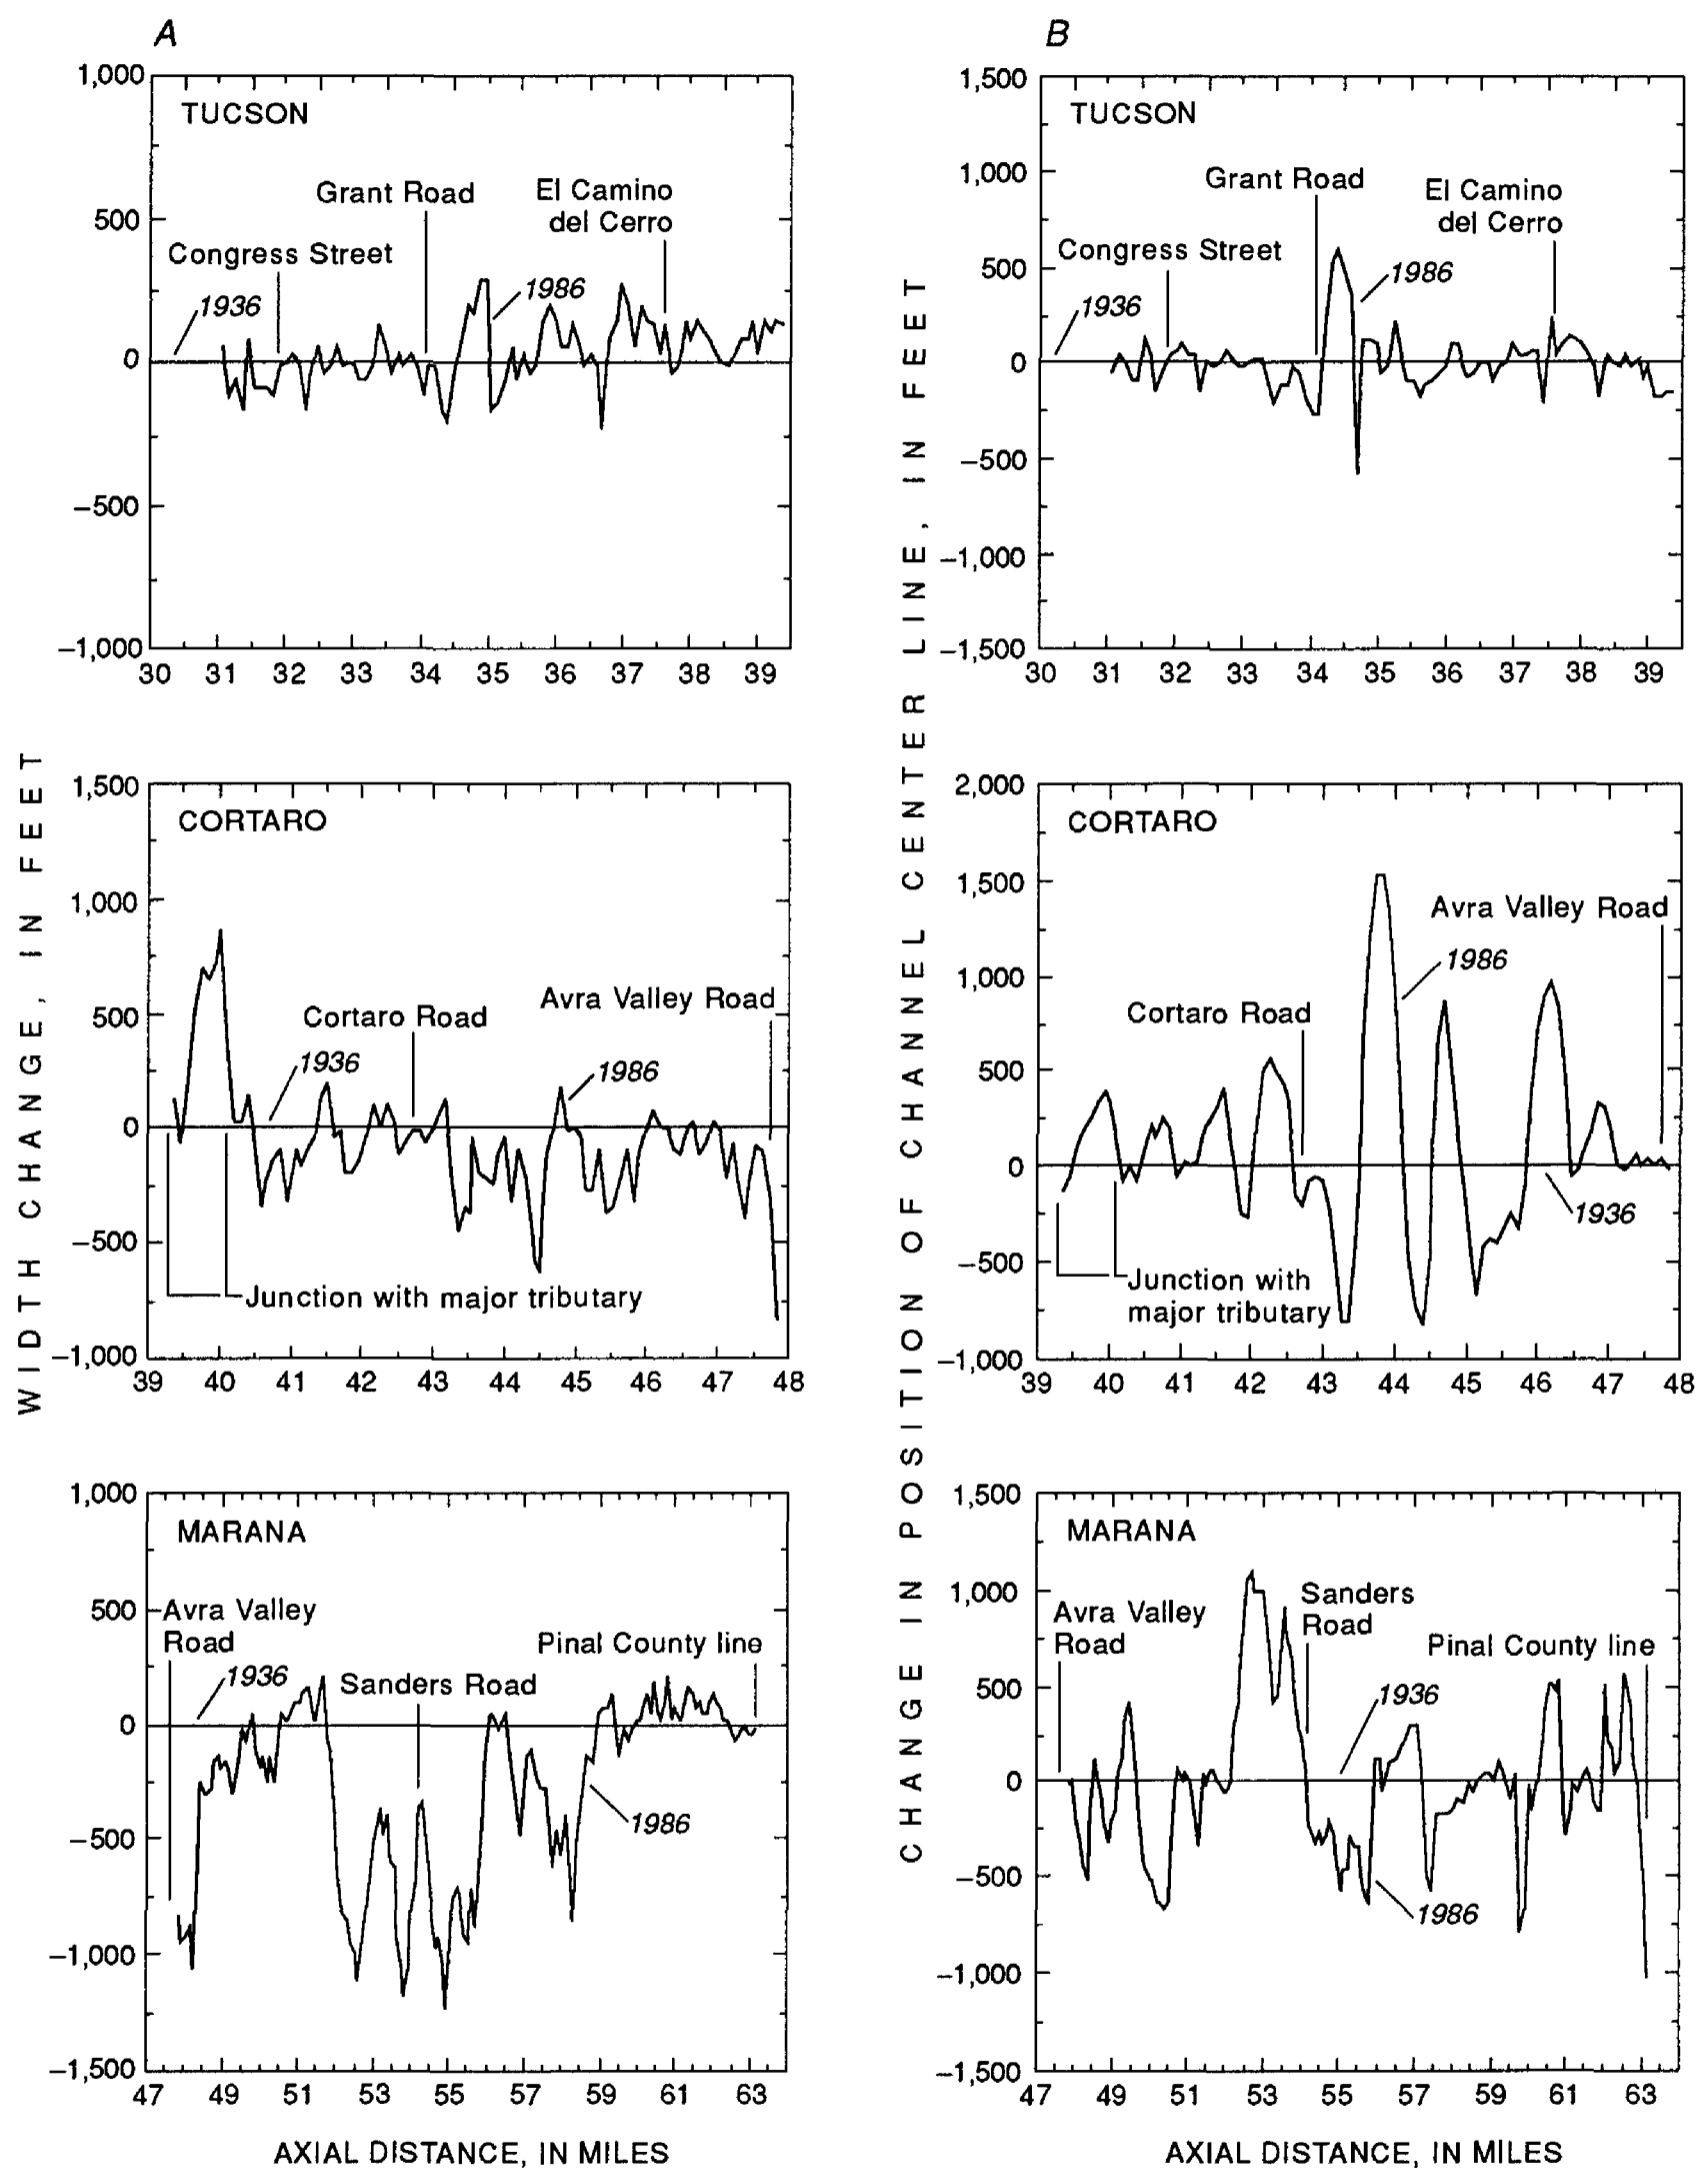
Figure 4. Channel changes on the Canoa, Sahuarita, San Xavier, Tucson, Cortaro, and Marana reaches, 1936–86. *A*, Width change. *B*, Change in position of channel center line. Positive values indicate shift in position toward left side of channel; negative values indicate shift toward right side.

From 1936 through 1986, channel change on the Santa Cruz River was characterized by an increase in width and a decrease in length throughout most of the study area (table 1 and fig. 4). Most of the reduction in length was the result of channelization. The increase in mean width would have been greater except for human intervention such as bank armoring, which inhibited channel widening, and landfill operations or channel maintenance, which narrowed channels artificially. Net vertical change in the same period was primarily degradational (fig. 5).

The Canoa reach is characterized by a generally unentrenched, sandy channel that occupies a 5,000-foot-wide active flood plain. The reach has undergone major channel widening (fig. 4A); however, little natural change occurred before the floods of 1977 and 1983. Much of the change in channel position and stream length (fig. 4B and table 1) resulted from artificial channelization that has been in place since at least the 1950's; 70 percent of channel widening during the study interval was caused by the 1983 flood.

The San Xavier reach was the most continuously unstable reach of the Santa Cruz River during the study period (fig. 4C). The channel is entrenched 20 to 30 ft into weakly indurated alluvium of Holocene age that fails readily when undercut during flows. The arroyo has widened continuously along most of the reach throughout the study period. Mean width increased 2.3 times, and median width increased by almost three times between 1936 and 1986. Downstream from Martinez Hill, sand and gravel operations and other activities, such as landfill operations, have altered the arroyo; however, upstream from that point, disturbance from human activity has been slight.

The Tucson reach has shown the least lateral instability during the study period (fig. 4D). Much of the apparent stability is artificial—either as a result of bank armoring, which has prevented channel change, or of artificial filling, which has obscured the record of change occurring between 1936 and 1986. Parts of the reach underwent about 15 ft of degradation between the 1950's and 1976 (fig. 5J).

The Cortaro and Marana reaches have had the most complex record of channel change since 1936 (fig. 4E-F). The Marana reach has changed from a wide, braided channel to a compound channel that is less than half the width of the channel in 1936. Both reaches were unstable before 1966 when they had sparsely vegetated ephemeral channels and would undergo large, frequent shifts in channel position. In 1970, when flow from sewage
